# DEVELOPMENT OF 20mm PLASTIC/ALUMINUM CARTRIDGE CASE

#### AAI CORPORATION

TECHNICAL REPORT AFATL-TR-74-62

**MARCH 1974**

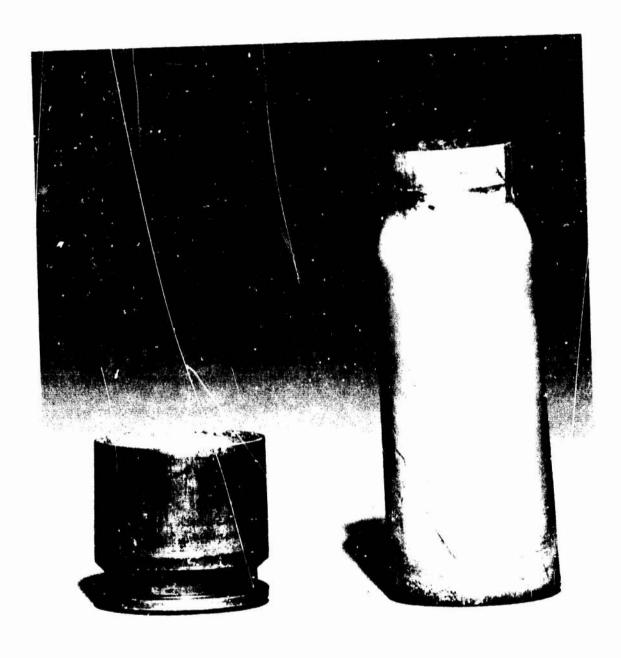
Figure 12. Typical Base/Case Joint Failure

Rounds using cases molded in the new mold were loaded and test fired, in the M61 gun, at -65°F and +165°F. All of the cases fired cold functioned properly. The hot rounds were less satisfactory. All of them had neck separations, and seventeen percent had base/case joint failures. The joint failures were later to be solved, but the neck separations remained.

To solve the base/case joint failure, several modifications were tried: (1) the bases and cases were lubricated with Electrofilm Lubribond-A to alleviate frictional drag between the round and the chamber; (2) the base was shortened by 0.008 inch to 0.010 inch and electrofilmed (work done on a previous contract had shown that cases which were too long broke at the base/case joint in compression during chambering); and later shims were added to the front of the case to lengthen it by 0.020 inch and 0.030 i.ch. (The cases modified as noted in (2), above, had a higher failure rate than the standard length case. The break now appeared to be a tensile rather than a compressive failure.)

Lengthening the case by 0.030 solved the base/case joint failure problem. The mold length was increased by that amount and cases subsequently molded and fired functioned without repeating this failure. The neck separation problem remained unsolved.

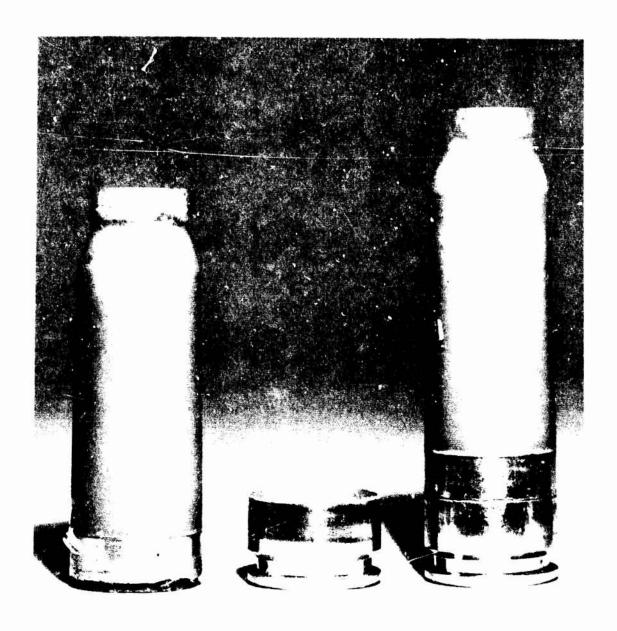
The bases used with case type 1 through type 14 were identical to those used on the last contract. These bases suffered circumferential splits or separations 0.35 inch back from the open end. (See Figure 17.) This places the crack at the thinnest point of the first chevron. In the early part of the program, it was believed that this failure was a result of a lack of fillets in the corners of the chevrons and the exceptionally heavy press fit between the case and the base (0.015 to 0.020 inch). The fillets could not be corrected in the cases already made, but they were added to the production bases. To relieve the heavy press fit on existing bases, a 0.003-inch cut was taken on the chevrons (at an angle (4°35') matching the chevron joint, increasing the ID by 0.006). Bases bearing this modification were used with case types 15 through 20. This modification reduced the incidence of base failures (from 16 percent to 5.5 percent) but did not eliminate them.

The remainder of the bases used on the contract were from the production run. These bases were the same as those used on the previous contract. Of 23 rounds (utilizing the production base and type 21 or 22 case) fired at +165°F and 12 rounds fired at -65°F fired from the M61 gun, nine of the bases were cracked circumferentially 0.35 inch from base/case joint (at first chevron), three separated at the same location, and three were eroded. This was a base failure rate of 60 percent, the highest ever experienced on this contract.

Figure 17. Typical Base Failures

After carefully examining the bases that failed and comparing them to bases from the previous contract which had not failed, it was determined that the new bases were not able to distort enough to seat firmly on the sloped bolt face. This caused them to cock in the chamber and fail circumferentially. Examination showed the hardness of the new bases to be the same as that of the old bases, and the material had been certified to be the same type (7975-T6). Another possible variation in material which might cause the brittleness was the forming process for the bar stock (rolled versus extruded). It was felt that this type of deviation was one which must be tolerated in a production item, so a means was sought to compensate for such differences. Three processes were employed to solve the base crack problem: (1) lubricating the base with electro-film Lubribond A (to eliminate frictional drag between the base and the
